CORROSION BEHAVIOR OF LOW-CARBON STEEL AND STAINLESS STEEL 304 UNDER TWO SOIL CONDITIONS AT PANTAI MENGABANG TELIPOT, TERENGGANU, MALAYSIA

Suriani Mat Jusoh^{1,2}, Wan Mohd Norsani Wan Nik^{1,3,4}, Nor Azila Azman¹,
Mohammad Fakhratul Ridwan Zulkifli^{1,3*}

¹Faculty of Ocean Engineering Technology and Informatics

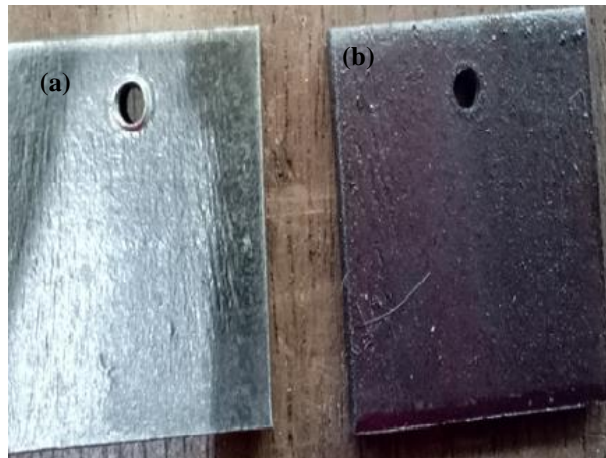
Figure 1. (a) Low carbon steel coupons and (b) Stainless steel 304 coupons

All coupon types were cut (38 mm x 25 mm x 3mm) uniformly. The LCS and SS 304 coupon density is 7.85 g/cm³ and 7.98 g/cm³, respectively. There was no pre-treatment of the coupons before exposure to the soil sites and finally, the coupons were buried in a depth of 30 cm at both selected sites. Figure 1 shows both coupons after the surface preparation process.

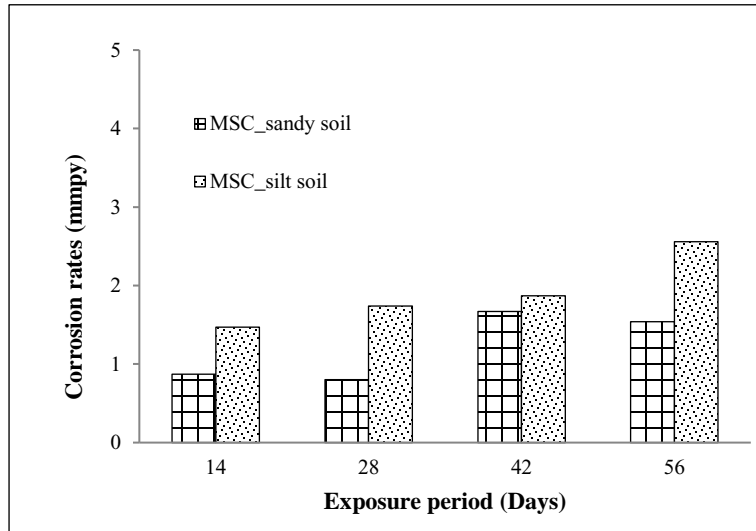
Figure 6. Corrosion rates in LCS coupons from sandy soil and silt soil sites

At 14, 28, 42 and 56 days of exposure, the corrosion rates for the LCS from sandy soil were 0.87 mmpy, 0.80 mmpy, 1.67 mmpy and 1.54 mmpy, respectively, giving

a total average of 1.22 mmpy. In the silt soil, the corrosion rates were 1.47 mmpy, 1.74 mmpy, 1.87 mmpy and 2.56 mmpy, respectively, representing an average of 1.91 mmpy as shown in Figure 6. As the corrosion rate's value is directly proportional to the percentage of weight loss, the trend for corrosion rate was found to be similar to the weight loss percentage trend.

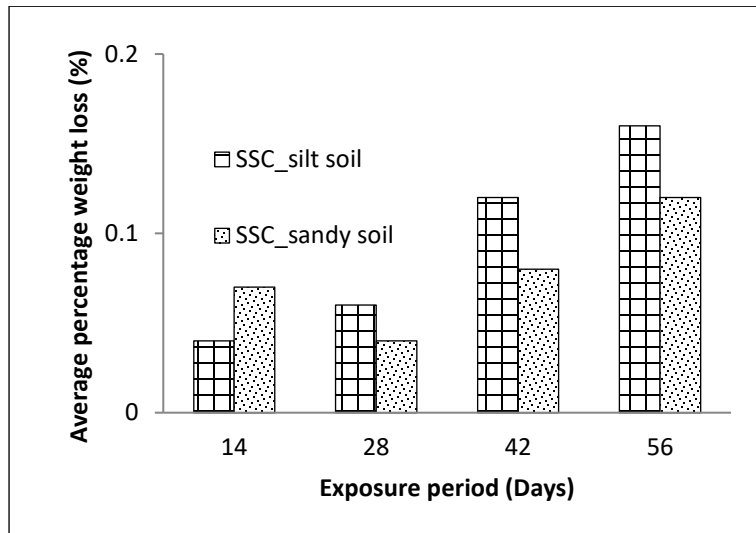
Figure 7. Percentage weight loss in SS 304 coupons from sandy soil and silt soil sites

In the sandy soil site, weight loss percentage for SS 304 coupons were 0.069%, 0.039%, 0.076% and 0.118% after 14, 28, 42 and 56 day respectively, with a total average of 0.076%, while the weight loss percentage in the silt soil were 0.035%, 0.055%, 0.118% and 0.165%, respectively, for combined average of 0.093%. Here, we see a near-similar increasing pattern as noted earlier, except for the dips on day 28 at both sites, as depicted in Figure 7. SS304 coupons show lower weight loss percentage due to its higher corrosion resistance nature as published by Anwar et al. (2017) in their study on the corrosion rate of SS304 and SS310 alloys in atmospheric, underground and seawater splash zone in the Arabian Gulf. It was determined that the corrosion rate for both SS304 and SS316 exposed under atmospheric, underground and seawater splash zone conditions is low due to higher corrosion resistance [8]. However, silt soil still gave a significant factor in weight loss percentage as it shows a higher weight loss percentage for SS304 compared with the coupons in sandy soil. Once again, moisture has become a major

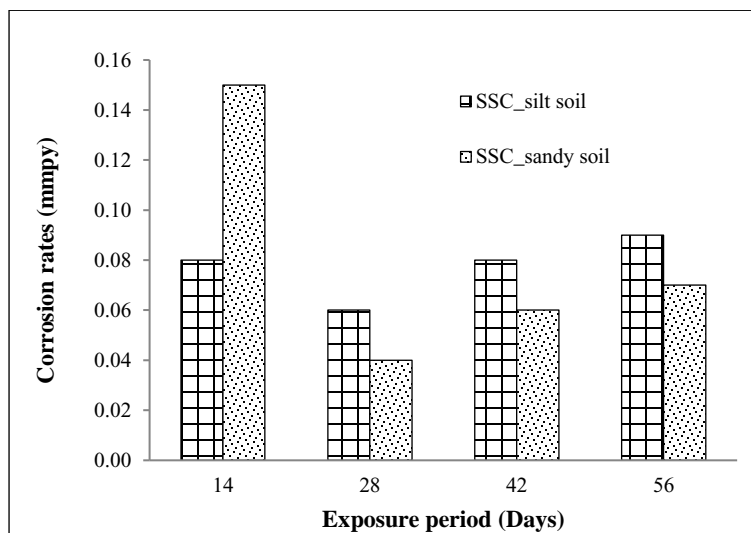
Figure 8. Corrosion rates in stainless steel 304 coupons from sandy soil and silt soil sites

Corrosion rates for the SS 304 coupons from the sandy soil site were 0.15 mmpy, 0.04 mmpy, 0.06 mmpy and 0.07 mmpy after 14, 28, 42 and 56 days, with a cumulative average of 0.08 mmpy. For the silt soil sites, corrosion rates were 0.08 mmpy, 0.06 mmpy, 0.08 mmpy and 0.09 mmpy, respectively, for a cumulative average of 0.08 mmpy in Figure 8. The corrosion rate for SS304 was found to be lower than LCS due to its better corrosion resistance. The observed pattern for SS 304 in silt soil is higher than sandy soil due to more significant moisture content in this type of soil. However, after 14 days of exposure, the percentage of weight loss and corrosion rate for SS304 were higher in the sandy soil than silt soil. This is due to the susceptibility of SS304 towards localized corrosion compared to LCS, which generally exhibits uniform corrosion [10]. Localized corrosion could be enhanced by the chloride ion concentration in which sandy soil will entrap more chloride caused by marine aerosol. The trend was found to be inversed after 14 days and
